Coastal Processes Assessment for Brevard County, Florida, with Special Reference to Test Plaintiffs

by *Nicholas C. Kraus, WES*
Mark R. Byrnes, Applied Coastal Research and Engineering, Inc.
Anne-Lise Lindquist, Consultant

Prepared for U.S. Department of Justice

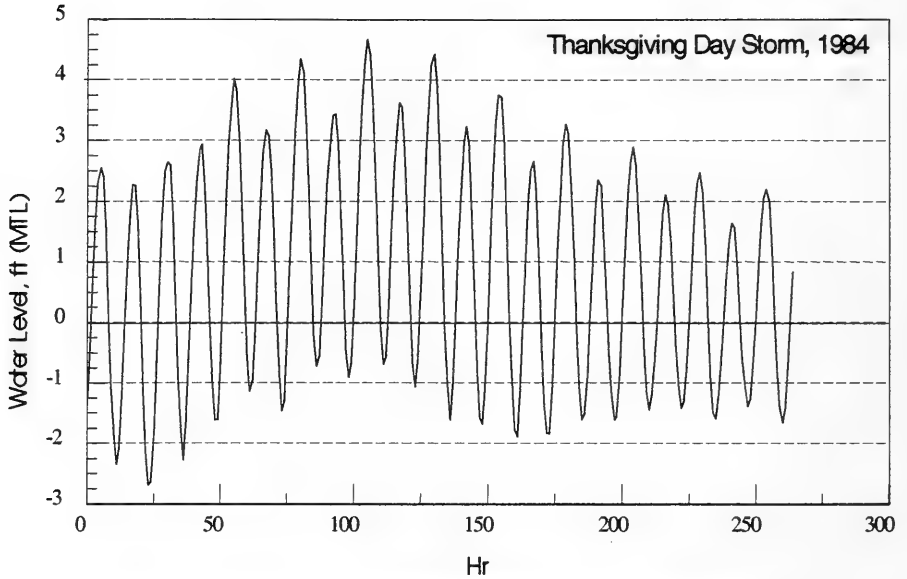
Figure E-1: Thanksgiving Day northeaster, 1984 water level, starting 00 hr 841119.

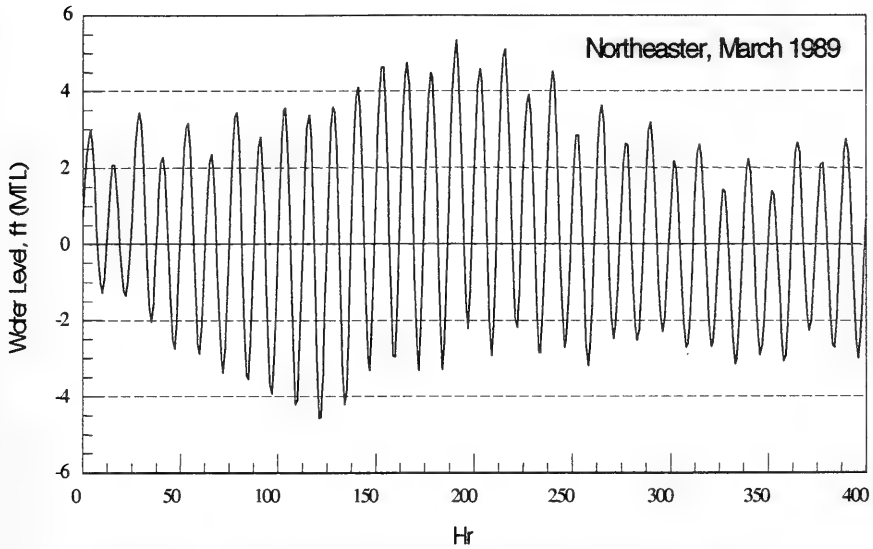
Figure E-3: Northeaster of March 1989 water level, starting 00 hr 890301.

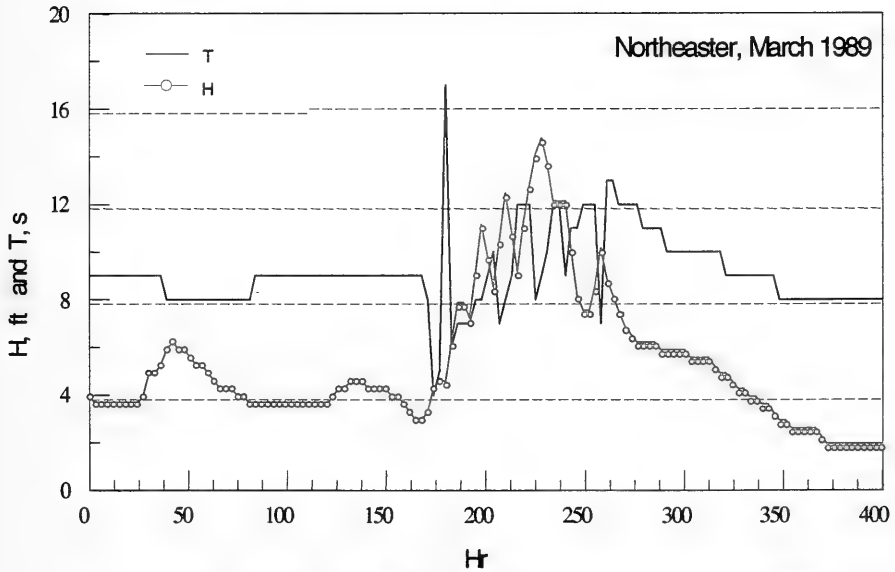
Figure E-4: Northeaster of March 1989 wave height and period, starting 00 hr 890301.

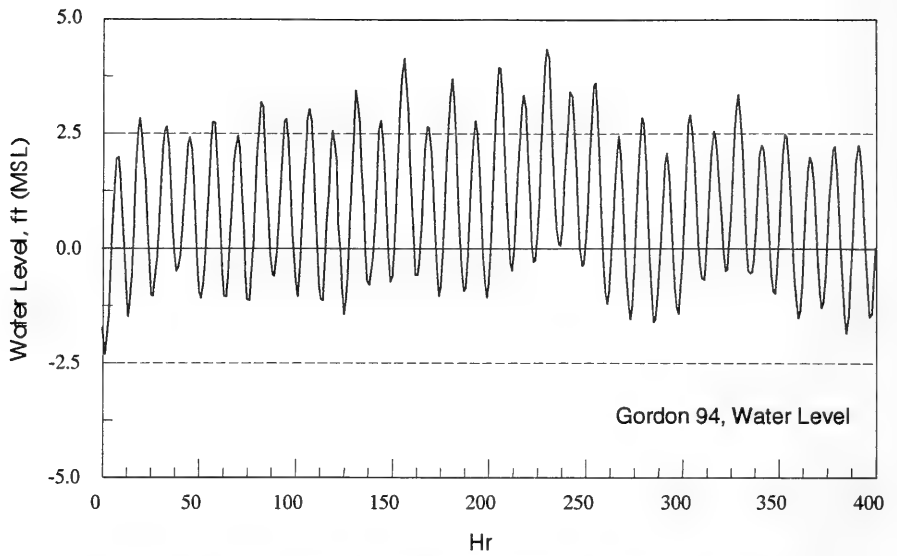
Figure E-5: Tropical Storm Gordon, 1989 water level, starting 00 hr 941110.

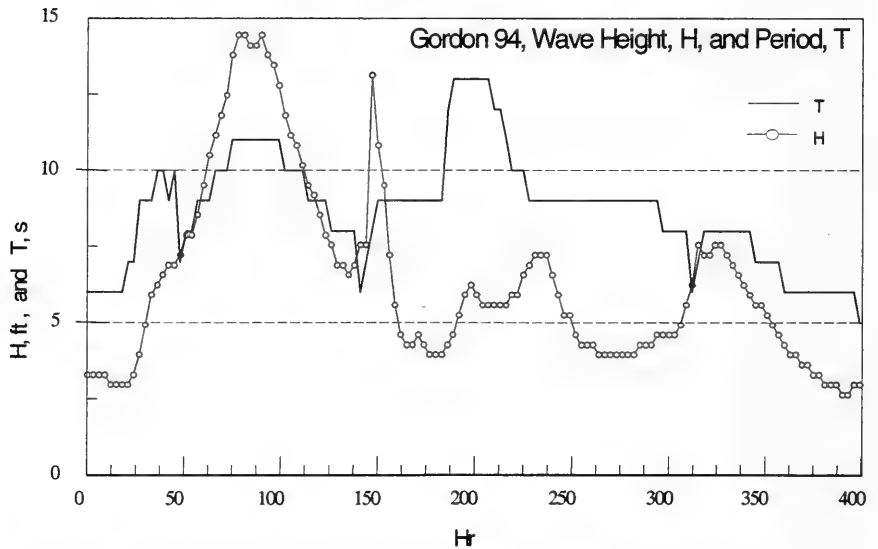
Figure E-6: Tropical Storm Gordon, 1994 wave height and period, starting 00 hr 941110.
